Muck Reduced 2.4' in 3 Years - An Independent Study on the Effectiveness of Vertex Aeration to Eliminate Accumulated Sediment

Lewiston's East Twin Lake Develops An Aeration System

East Twin Lake Aeration Study

Aeration of East Twin Lake Sediment, BOD and Oxygen Results

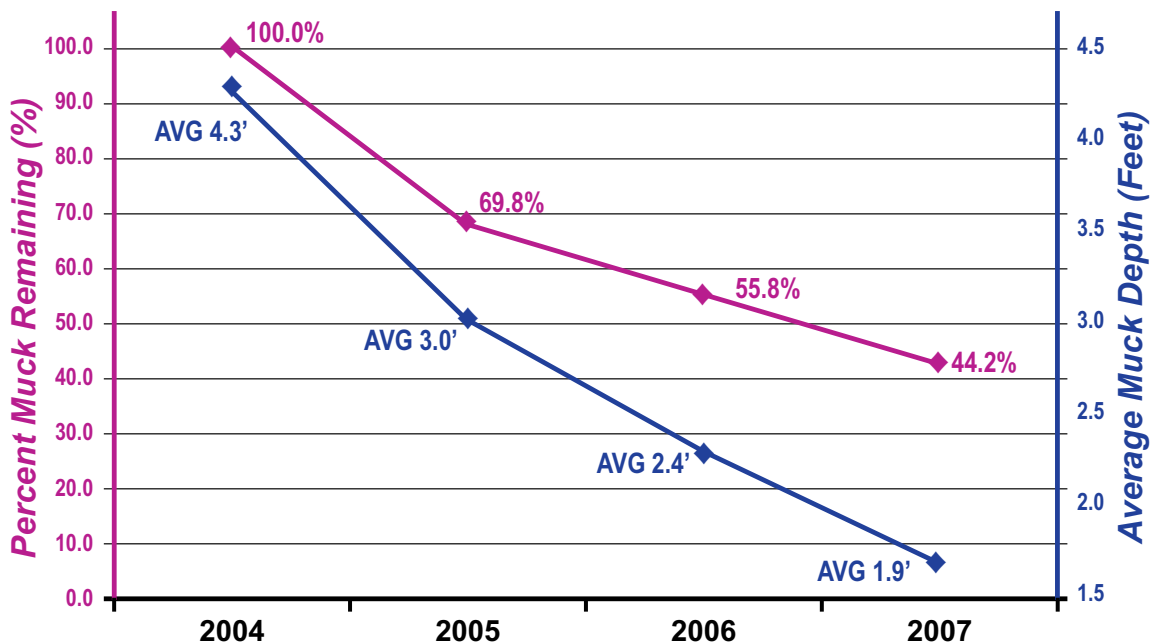
East Twin Lake Cove: Average Muck Accumulation (Yearly Averages from Sites 1-6)

We appear to be exceeding our conservative projections. Testing results are demonstrating continual drops in the undesired sediment levels. After two and a half years of operation, tests are revealing approximately two feet less of sediment in our lake. These tests are conducted 4 times per year in the same locations. Data retrieved from the tests demonstrates reduced sediment levels. These are encouraging results.

In July 2004, eight Vertex Air 3 XL systems were installed by Tri-County Aquatics in a 160 acre cove of an 900 acre lake. At the time of installation, muck measurements with a "sludge judge" were taken at six locations to determine the amount of muck on the bottom. Three of the sites showed levels of 6 and 7 feet of muck and the average for all 6 sites was 4.3 feet of muck. Oxygen readings were taken at the surface and at the bottom to assess the quality of the water. The dissolved oxygen at the surface was 4.0 mg/l while the oxygen level at the bottom was 2.0 mg/L, which is virtually an anoxic environment. A water sample sent to a lab to determine the BOD (Biological Oxygen Demand) returned results of a BOD of 58 mg/L, which was much higher than the available oxygen in the water could oxidize and reduce.

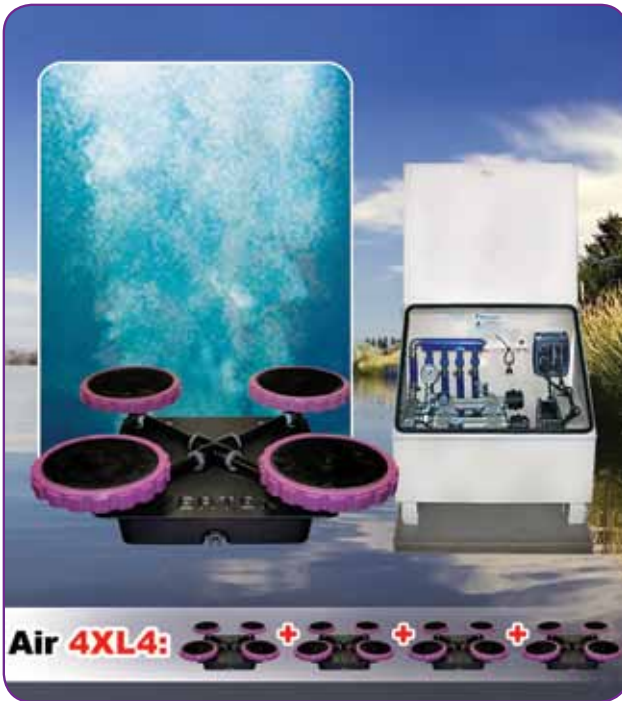
Eight Vertex Air3 XL4™ Systems installed at East Twin Lake Cove

The Vertex Air3 XL4™ pond aerator is a super-efficient, affordable and safe system. In a typical pond, an Air3 XL4™ can aerate approximately 4-7 acres depending on shape, slope, oxygen demand and other factors. Two 1/2hp (0.75kW) Brookwood™ SafeStart™ compressors, housed in our rustproof aluminum outdoor cabinet, feed three bottom mounted XL AirStations™ utilizing Vertex's MicronBubble™ technology.

The rising force of millions of bubbles circulates the entire water column, entraining bottom water up to the surface allowing vital oxygen to be absorbed and poisonous gasses expelled. With no electricity in the water, Vertex's aeration systems are safe for any type of water recreation.

- ◆ 24 XL4 AirStations: (96) 9" flexible membrane discs
- ◆ 8 QuietAir Cabinets: (16) 1/2hp Brookwood Compressors
